Manhole Inspection Summary

Manhole # S37QQ_004MH

Insp Date: **1/17/07 8:49 AM**

Location Address: **600 LOCH RAVEN RD**

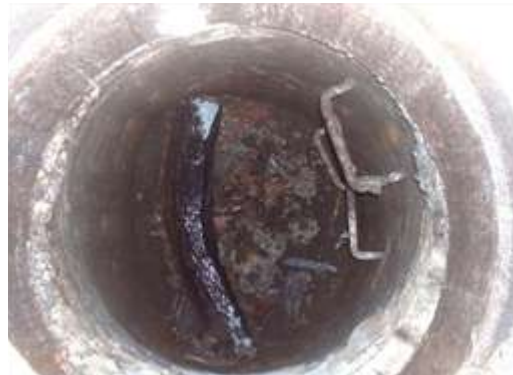
Top View

Bench ☒ Exists Material: **Brick** ☐ Parged ☒ **Debris** (not Condition related)

Steps Count: **3** Missing: **0** ☒ **Corroded**

Surcharge ☒ **Evidence Of Surcharge** Depth: **1** (ft.) ☐ Active Surcharge Present

Corroded steps. Evidence of surcharge - Bench debris.

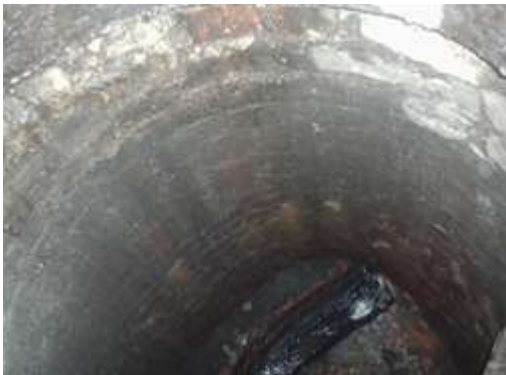
Defect

Frame Offset: **2** (in.) Condition: ☐ Sound ☐ Cracked ☒ **Leaks**

Condition: ☐ Sound ☐ Cracked ☐ Root Intrusion ☐ Loose Brick ☒ **Deteriorated**

Infiltration: ☐ None ☒ **Joint** ☐ Cracks ☐ Mortar ☐ Roots ☒ **Wall**

Frame leaks. Adjustment deterioration and infiltration.

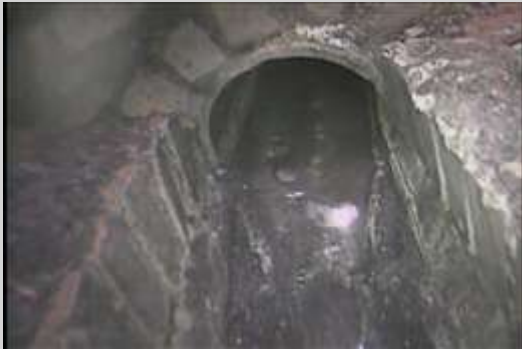
8 in. Circular Gravity Sewer Pipe Out @ 12 O'Clock

Deposits: ☐ None ☒ **Mud** ☐ Sludge ☒ **Debris** ☒ **Grease**

Silt Depth: **1** (in.) Deposits Extent: **Light**
